# TERMINAL BUILDING EVALUATION

This report evaluates the existing Terminal Building at Frederick Municipal Airport (FDK) to determine the suitability of the building for continued use as a restaurant and Airport operations administrative offices. The on-site evaluation was conducted on November 1, 2004 by URS Corporation personnel.

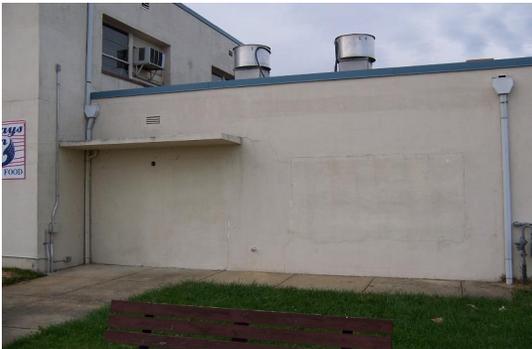
Infill Masonry at Removed Windows

The exterior envelope on the first and second levels is stucco on CMU walls with accents of brick at the center core of the building. The stucco exhibits several areas of stress cracks, some of which are where windows have been removed and in-filled with masonry before being covered with stucco. Other areas show indications of minor cracks in the masonry backup wall. The exterior of the tower is metal lap siding.

- Exterior walls have many small cracks in the stucco surfaces in addition to the cracking where previous openings have been closed with masonry and are in need of much repair. It appears that some of the cracking may be settlement cracks; others may be thermal stress cracks. Typically infill openings, such as these, are hard to control to prevent further cracking in the future.

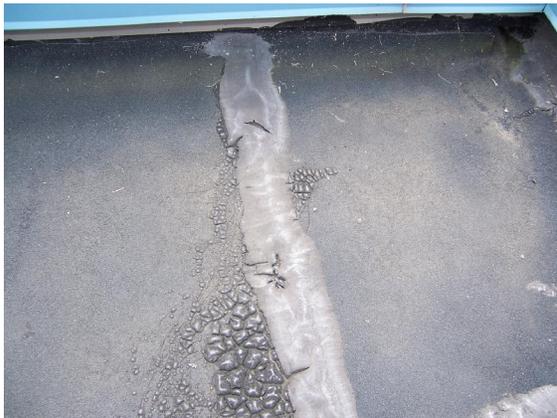
The roof has been a source of problem with numerous reports of leaks. The roof, which was last replaced in 1991, is a nearly level asphalt and felt built-up system on the first and second levels. The tower roof is slightly pitched from the beacon structure down to each edge. All are showing signs of age with separation of lap and edge joints and alligating (deterioration of the asphalt coating). An area along the east side of the second level has been built up to provide a slope away from the east parapet, apparently an indication of earlier problems. An area of ponded water was located on the north side of the tower. The roof feels slightly spongy when walking on it, which indicates that there is either a layer of insulation without a cover board installed under the roof membrane or wet insulation. The roof structure is expected to be wood frame and deck. This deck could be deteriorated from continued leakage problems. However, no visual or other confirmation can be provided without some destructive testing (i.e., removal of portions of the ceilings or roof membrane). Drainage is provided by several thru-parapet scupper/headers and downspouts on the exterior surface of the walls of the building. The tower roof has a perimeter gutter and downspout system on all four sides. The roof is approximately 13 years old; therefore, there is little, if any, value left in any warranty received at the time it was last replaced in 1991, especially if routine maintenance procedures were not performed.

Roof Membrane Deterioration

- The current roof system is in need of replacement. Although a more in-depth examination is needed to determine if the current leakage during storms is actually from the deteriorated roof system or problems in the tower structure above, the roof system needs attention. Due to its age, the roof should be replaced whether the building is to remain in service or just to protect the building and contents from further damage and deterioration. Further examination should be

made to verify the condition of the roof framing, and if damage is found, the extent of the damage.

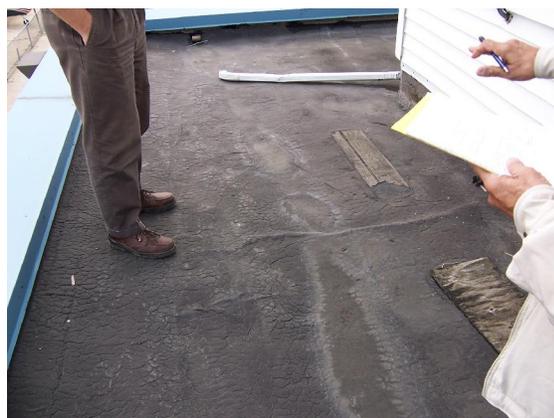
Built Up Slope in Roof Membrane

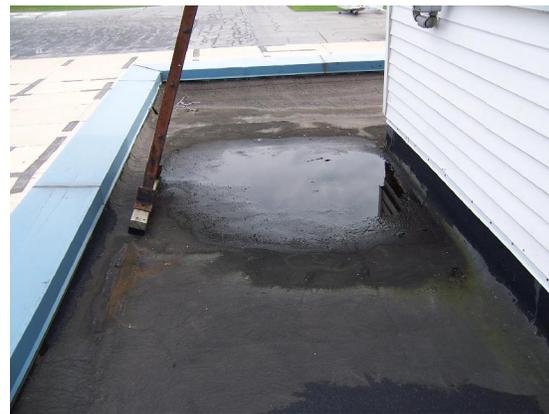
Ponded Water on North Side

The second level floor has some unevenness, which may be caused by the settlement of outside walls. The second floor roof leaks in heavy rain; ponding on the second floor roof contributes to the leaking. The second floor wood joists are also not visible due to the ceiling, but continuous wetting of the wood joists may have damaged the wood.

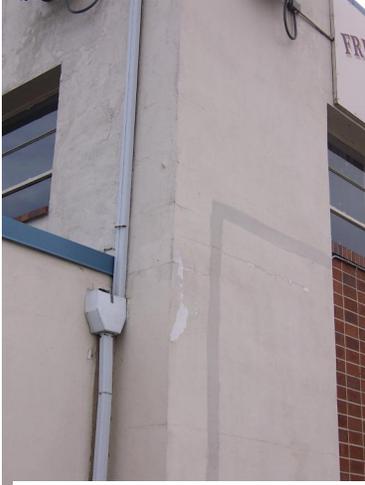
Scupper/Downspout System

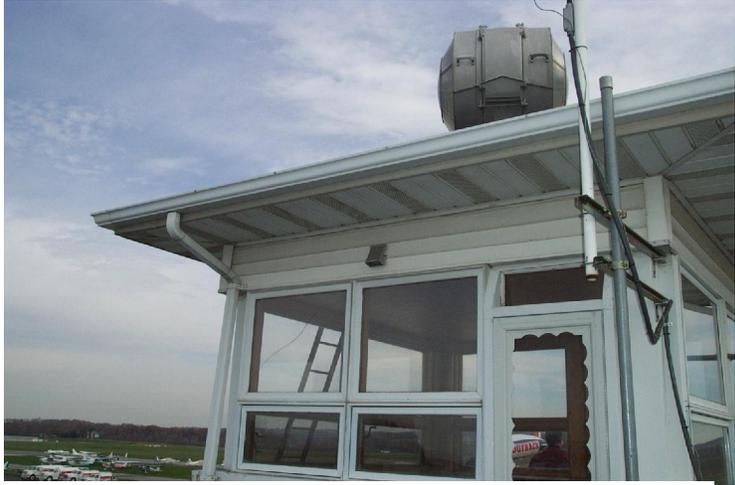
Tower Gutter System

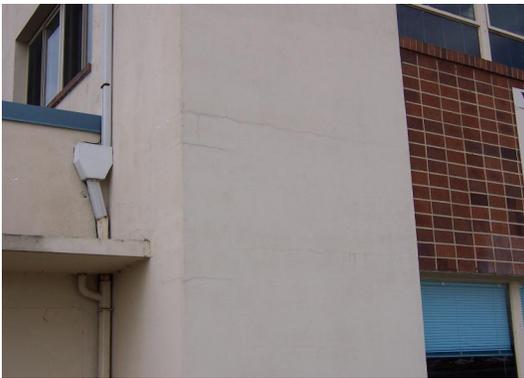
Cracks in Stucco Finish/Accent Brick Panels

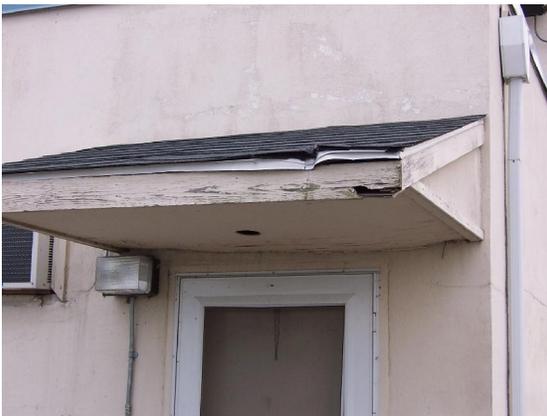
A small canopy has been installed above the exterior door to the kitchen to provide protection for users of that door. This canopy is damaged and deteriorated and in need of repair or replacement.

Canopy Above Kitchen Door

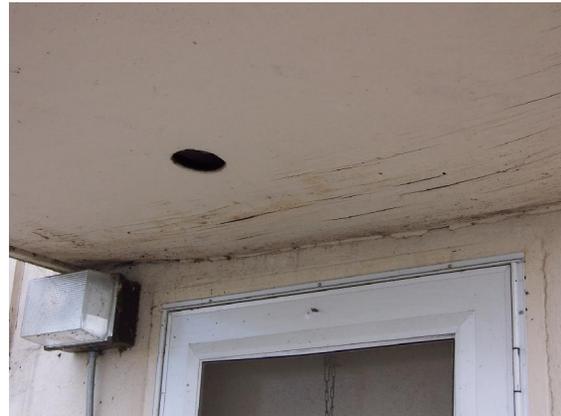
Soffit of Canopy Above Kitchen Door

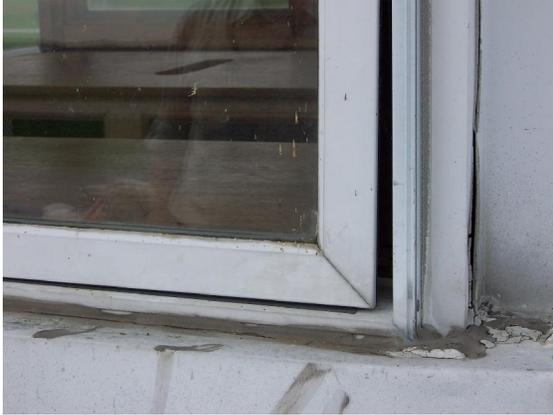
Most of the windows are single glazed steel casement type windows with no weather strip or thermal protection. Two windows on the south side of the second level have been replaced with vinyl double hung units with insulating glass. The tower windows are an aluminum-clad wood combination awning and fixed glazing in poor condition as exhibited by misalignment and leaks inside the tower.

Misalignment of Window Corners

- The existing fenestration system (windows and doors) is substandard in relation to current energy standards. Single glazed windows should be replaced with thermal break windows and insulating glass. Exterior wood doors should be replaced with steel or aluminum doors that are more resistant to the effects of weather.

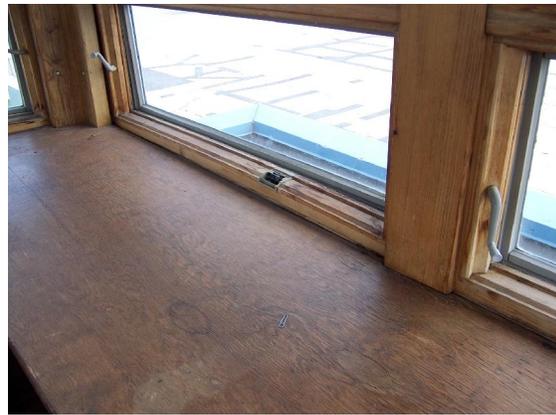
Water Damage Inside Tower Windows

The tower level is a wood frame with paneled walls, vinyl tile flooring, and vinyl flooring. The window system has badly deteriorated and the finishes inside the tower are being destroyed.

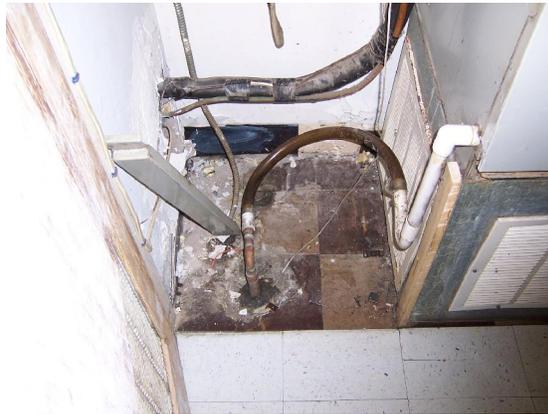
9 X 9 Vinyl Tile Under Carpet

There is no known hazardous material report on the building, but due to its age, it is likely that hazardous materials exist in the building. Areas of 9 by 9 inch vinyl tile, which are usually vinyl asbestos tile, were noted in the mechanical closet on the ground floor. They appear to be overlaid with 12 by 12 inch vinyl tile and subsequently, carpet in the restaurant area. The second floor is carpeted, probably over existing flooring which might be the same as the first floor. Visible piping insulation appears to be fiberglass with a kraft paper surface. Other likely areas of hazardous materials may be piping insulation in concealed areas, vinyl tile adhesives, roof flashings and cements, old light fixture ballasts containing PCB's, and lead paint. It is recommended that a hazardous material survey be performed prior to any work being performed on the building, including testing water for lead. Any work on the building should be with a caution to not disturb any suspicious materials.

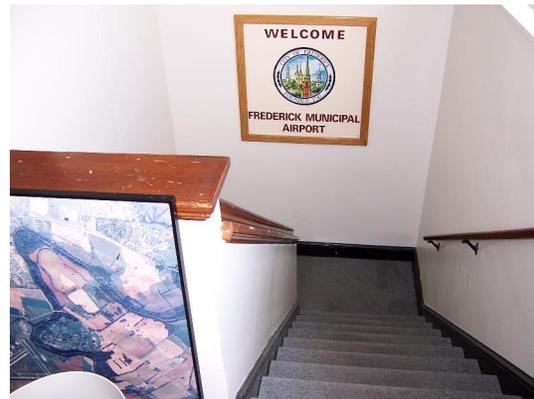
Access to the Airport Administration offices is by way of a narrow, steep stair adjacent to the entrance of the building, but through the restaurant dining room. This stair has no bottom landing and does not meet current code criteria for tread width and riser height. The only available restroom facilities for the Airport Administration are on the lower floor within the restaurant.

Stair to Operations Level from Top

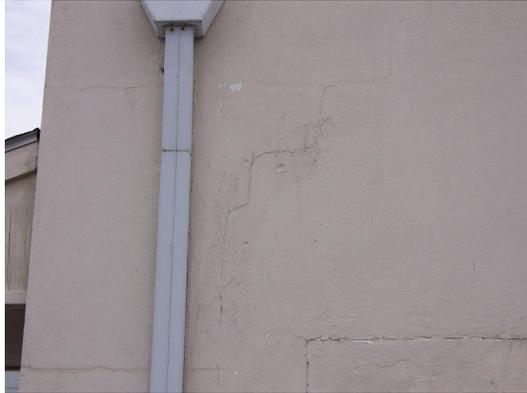
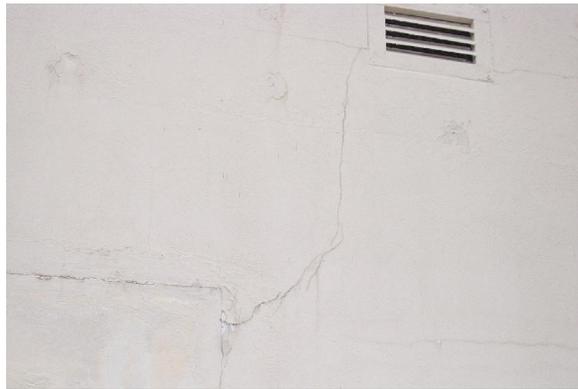
The building foundation is not visible. It is assumed that some footing settlement has occurred, which has caused cracks in the CU walls.

The CMU walls are finished with a stucco exterior. There are numerous cracks in the stucco. Some are diagonal starting from the corner of windows. Some are horizontal at the corner of the building. The interior of the walls does not show any distress. The basement walls do not show any cracks, but the walls around the stairwell leading to the basement have diagonal cracks.

Cracks in Masonry Walls

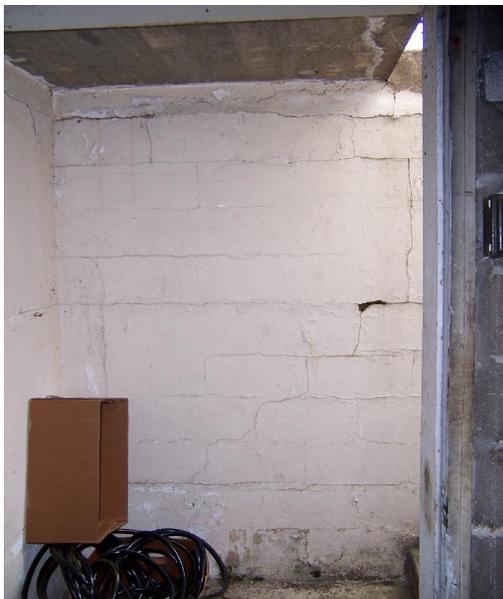
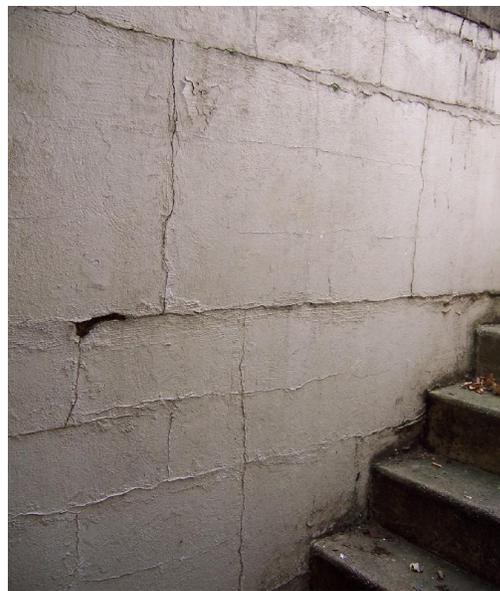
Cracks in Stairway Wall

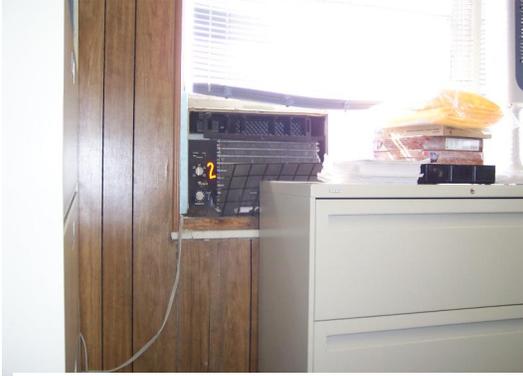
As indicated by Airport Administration and restaurant personnel, the existing heating and cooling system does not provide adequate heating and cooling in the upper level offices. The heating and cooling system has only one thermostat that is located in the restaurant area. This cycles the unit on and off depending on the selected temperature in the restaurant and not in the rest of the building. Wall units have been added to the upper level offices to provide supplemental heating and cooling to the offices.

Through the Wall AC Units added to Offices  
on Upper Level

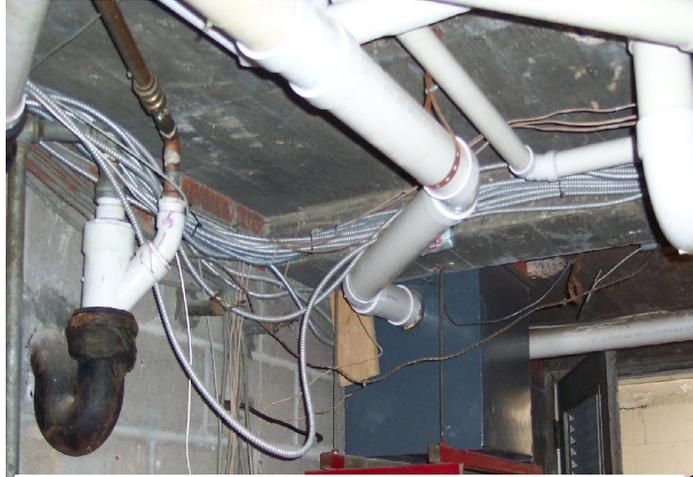
Piping from Kitchen Installed Above the Main Electrical Meter and Panels.

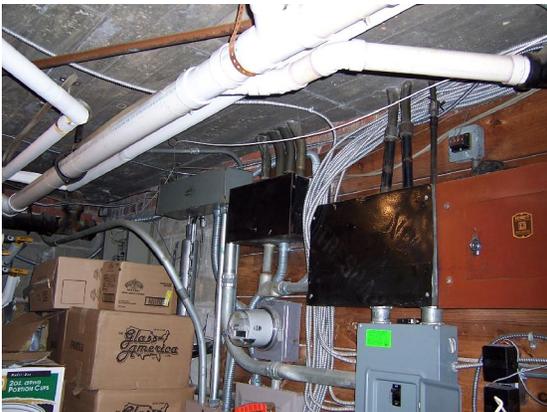
Piping from Kitchen Installed Above the Main Electrical Meter and Panels

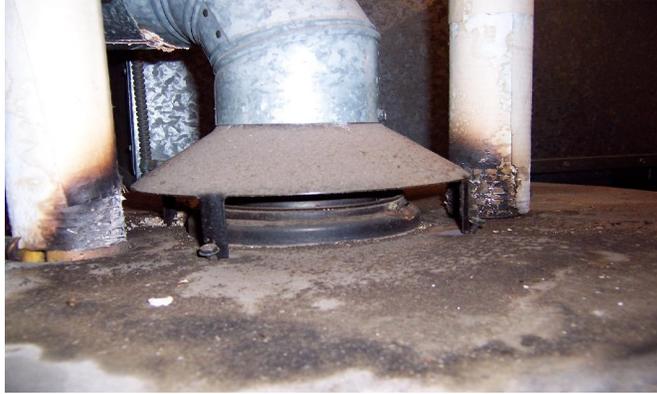
Insulation Burnt from Flue Gas (Inadequate Removal of Flue Gases Through Flue Pipe)

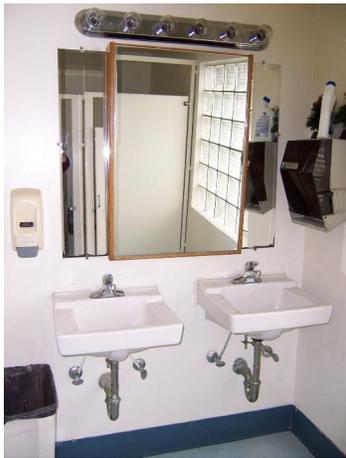
Male Toilet Room Existing Fixtures were in fair condition

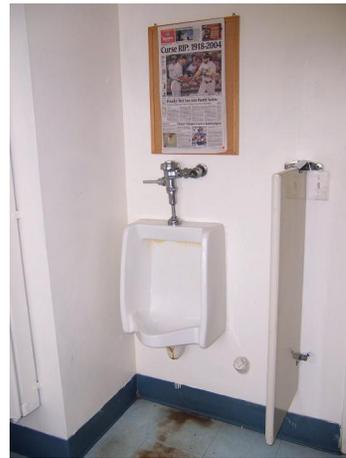
Male Toilet Room Existing Fixtures were in fair condition

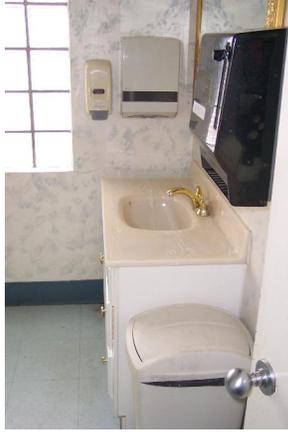
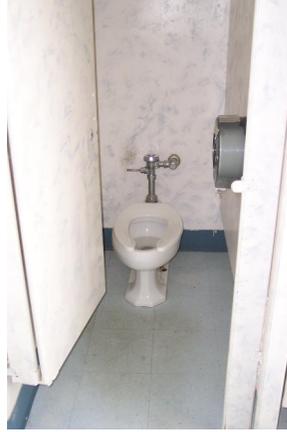
Female Restroom Existing Fixtures were in Fair Condition

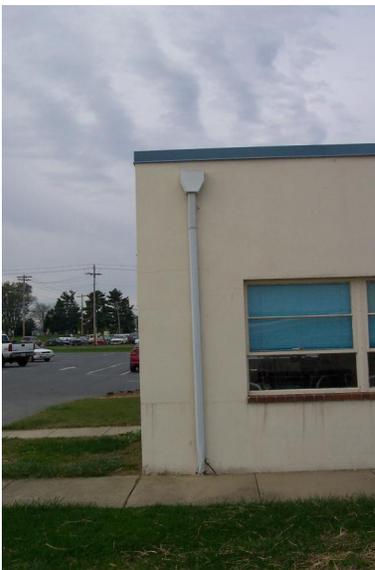
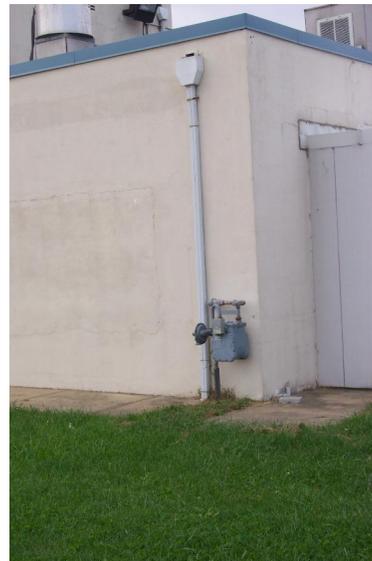
The roof is drained by rainwater pipes located on the exterior of the building. The rainwater pipes are in poor condition and have been flattened or dented in places, which inhibits the flow of water draining down to grade.

Roof Drained by Exterior Rainwater Pipes

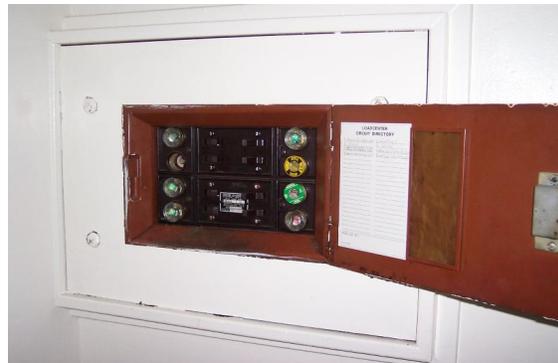
Original Electrical Panel With Screw in Fuses on Main Level for Lighting and Receptacles in Dining Area.

- The entire mechanical, heating, cooling and ventilation systems are outdated and need to be replaced with newer more efficient equipment.
- Some of the electrical system appears to date back to the original construction. Most of it is substandard and dangerous by today's standards and needs to be replaced.

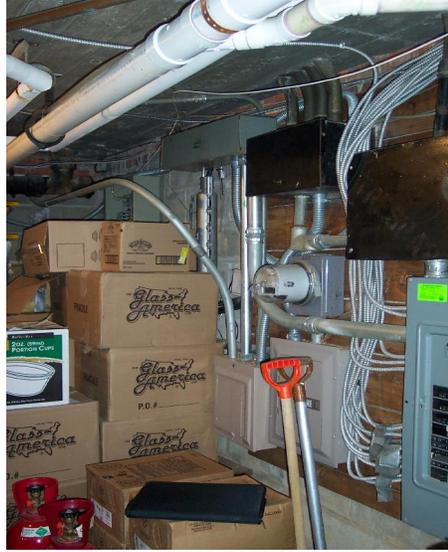
Piping from Kitchen Above Installed Above Panels. A Drip Pan Installed under the Piping to avoid water Dripping onto Panels.
